Development of Deltas in Some Danish Watercourses

Geografisk Tidsskrift, Bind 84 (1984)

Hasholt, Bent: Development of Deltas in Some Danish Watercourses. *Geografisk Tidsskrift* 84: 10-16. Copenhagen, January 1984.

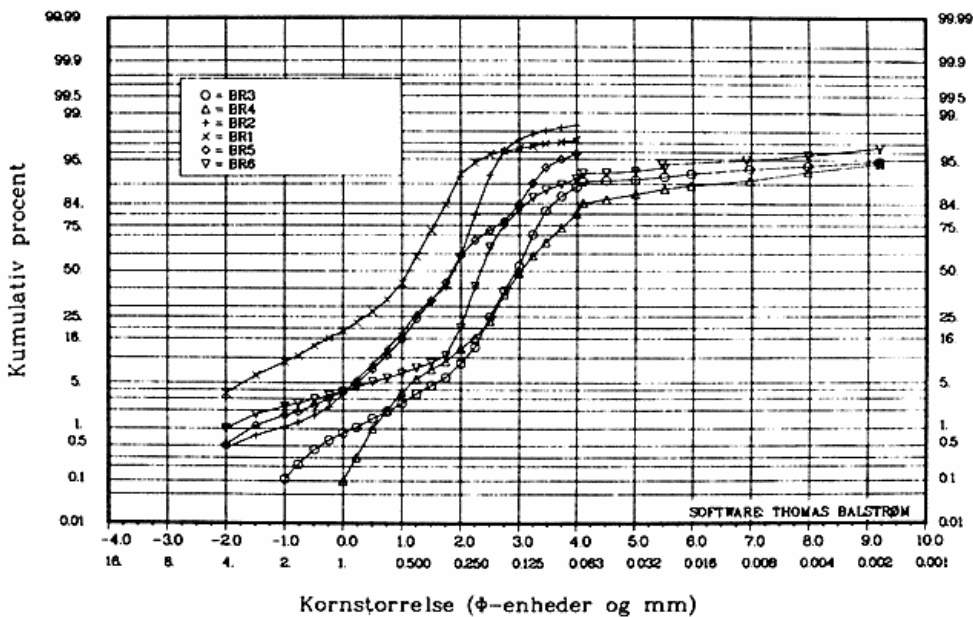
Fig. 6. The river Brede Å, selected grain-size distribution.
 Fig. 6. Brede Å, udvalgte kornstørrelsesfordelinger.

The grain-size parametres are shown in table 1 and fig.

6. The mean grain size upstream the front is 545μ , the sorting is rather poor, and the skewness indicates that the amount of fine sediment is too small for a normal distribution. The grain size at the foreset is slightly smaller and the skewness still negative. The rest of the samples shows significantly smaller grain sizes, the skewness has become positive with values that indicate surplus of fine sediment. The kurtosis has rather high values indicating that the distribution originates from different populations.
